# Composite Reinforcement of Wrinkle Bends Subjected to High Strain-Low Cycle Bending Loads

## Pipeline Pigging and Integrity Management Conference

## Abstract

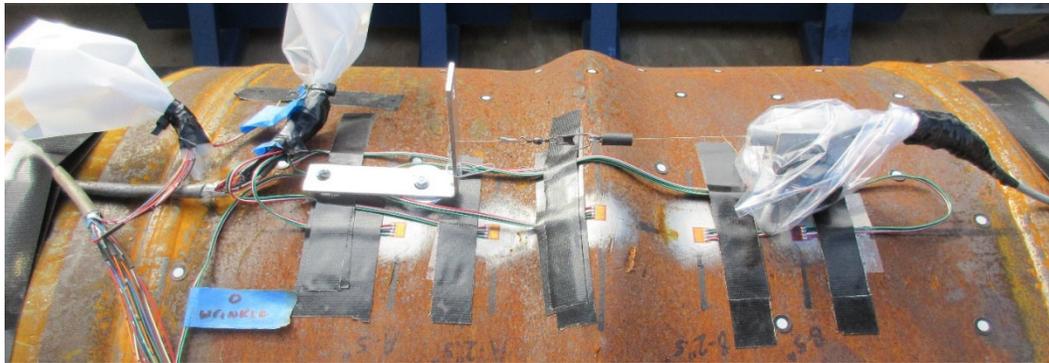
**Figure 1. Unreinforced wrinkle with instrumentation**

The purpose of the program was to determine the benefits that composite reinforcements would have on the fatigue lives of wrinkle bends subjected to fully reversible bending load cycles (i.e., subjecting the wrinkles to tension and then compression). Previous studies have shown that the use of composite materials can mitigate threats associated with wrinkle bends due to the additional axial stiffness provided by the reinforcements. The outcomes from this study provide additional data and information on how much reduction occurs in axial strain at the wrinkle and axial displacement across the wrinkle, and the increase in cycles to failure associated with the composite reinforcements. Table 1 provides a summary of the pipe sample sizes, composite material selection, and wrinkle information described by the wrinkle height (H), wrinkle length (L), and H/L ratio. All wrinkles were retrieved from the same pipe sample and had similar H/L ratios. Figure 1, Figure 2, and Figure 3

show the wrinkle geometries. For the reinforced samples pre and post composite installations photographs are shown for reference.

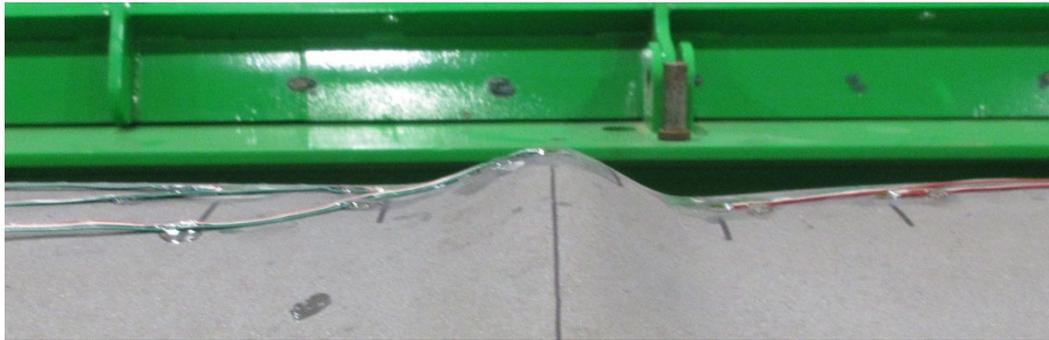
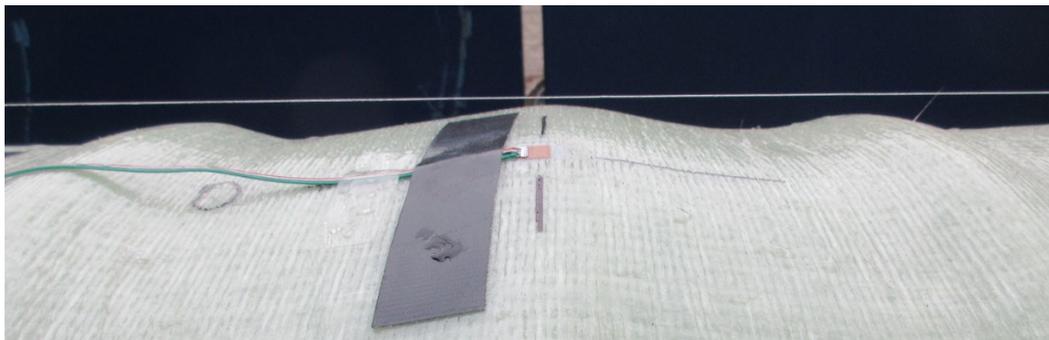
**Figure 2. Wrinkle pre (top) and post (bottom) repair with E-glass**

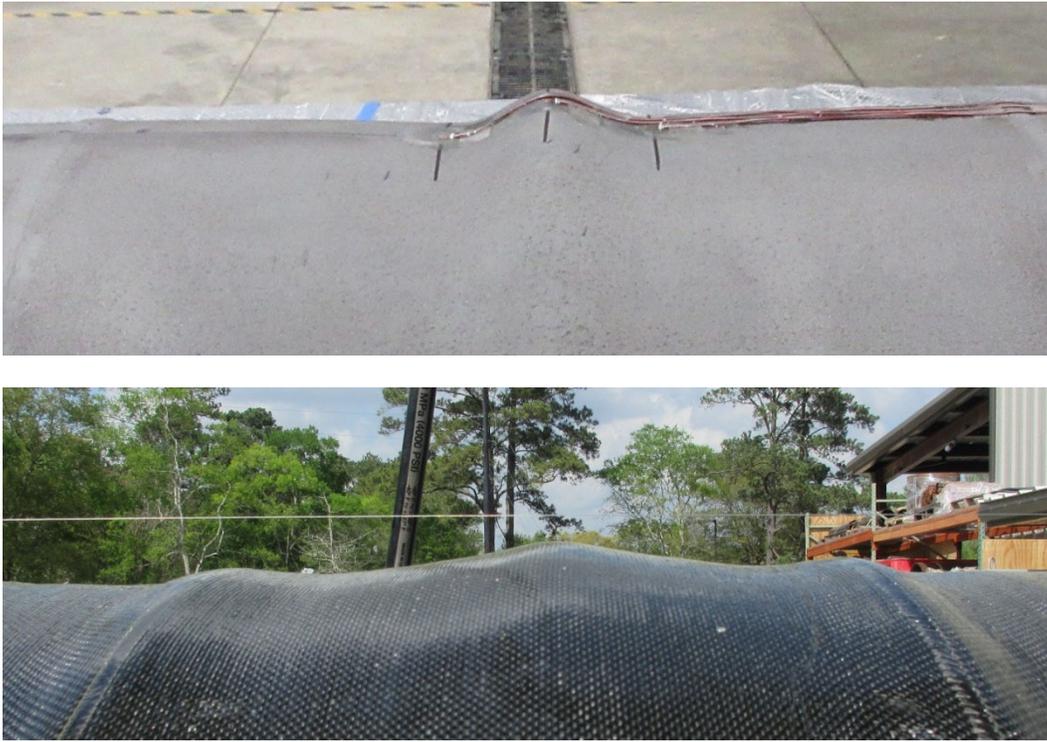
**Figure 3. Wrinkle pre (top) and post (bottom) repair with carbon fiber**

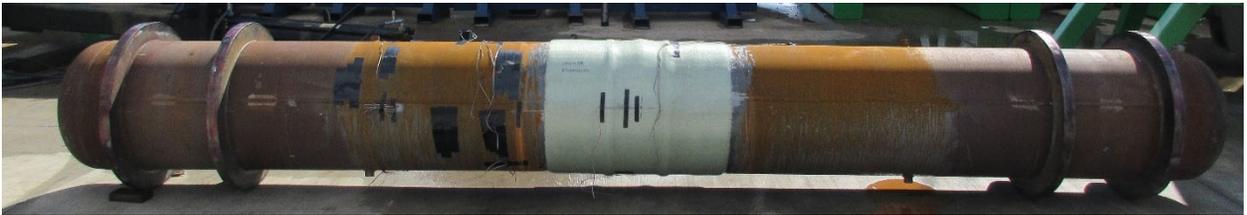
Figure 4. Wrinkle sample reinforced with E-glass composite wrap

Figure 4 and Figure 5 are photographs of the E-glass and carbon systems installed on the respective wrinkle bend samples. The repair lengths were approximately 37 inches. The same number of layers (12) were installed on both the E-glass and carbon test samples and included the following fabric lay-up. The total thickness of the E-glass repair was approximately 0.535 inches and the thickness for the carbon system was 0.336 inches.

- **Layers #1 & #2:** Axial-dominated layers
- Layer #3: Hoop-dominated layer
- **Layers #4 & 5:** Axial-dominated layers
- Layer #6: Hoop-dominated layer
- **Layers #7 & #8:** Axial-dominated layers
- Layer #9: Hoop-dominated layer
- **Layers #10 & #11:** Axial-dominated layers
- Layer #12: Hoop-dominated layer

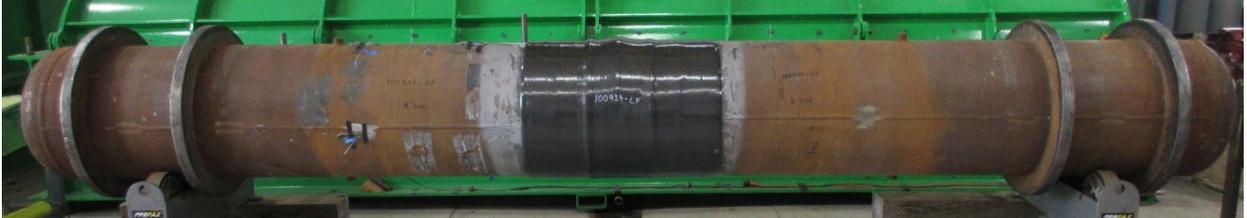
Figure 5. Wrinkle sample reinforced with carbon fiber composite wrap

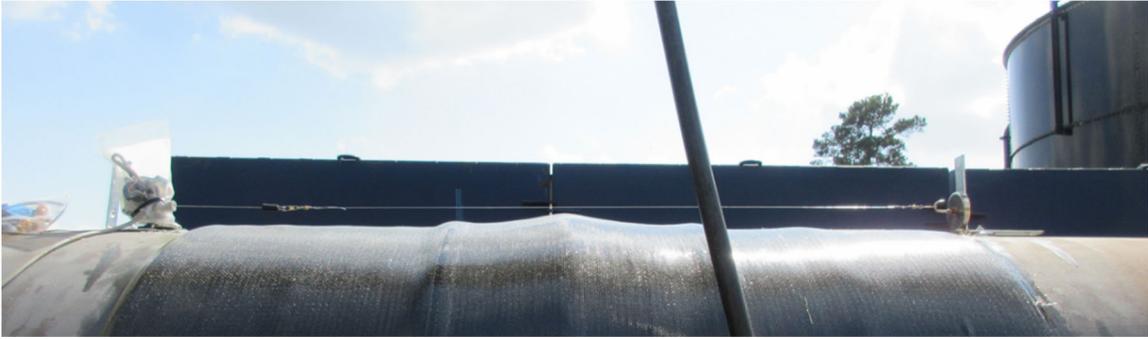
**Figure 10. String potentiometer installed on a reinforced wrinkle**  
(Carbon fiber reinforced sample shown)

A string potentiometer was placed across the wrinkle axial length to measure the axial displacement of the wrinkle during loading. Figure 9 is a schematic showing the displacement transducer (i.e., string potentiometer) location on the test samples, while Figure 10 is a photograph showing the string potentiometer on the carbon reinforced test sample. Pressure transducers were installed to measure the internal pressure of the sample as well as the internal pressure of the hydraulic cylinders.

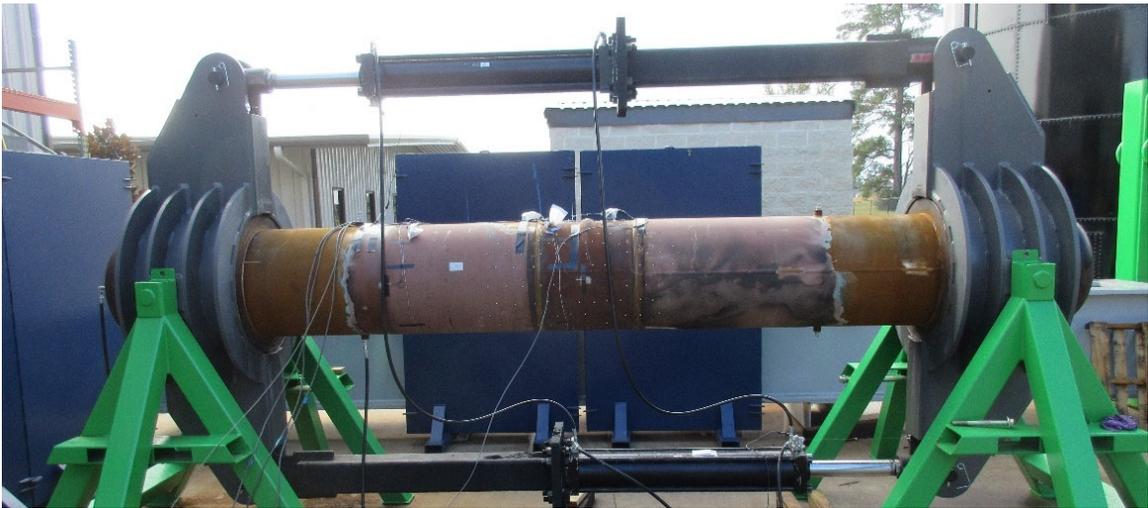
**Figure 11. Unreinforced sample in bending frame**

The test samples were placed in the bending frame as shown in Figure 11 (unreinforced sample). The samples were pressurized to an internal pressure corresponding to 72% SMYS (810 psig), where the pressure was held between 750-850-psig for the duration of the test. A bending moment was applied to the sample until a failure occurred, which is characterized by loss of internal pressure due to a leak.

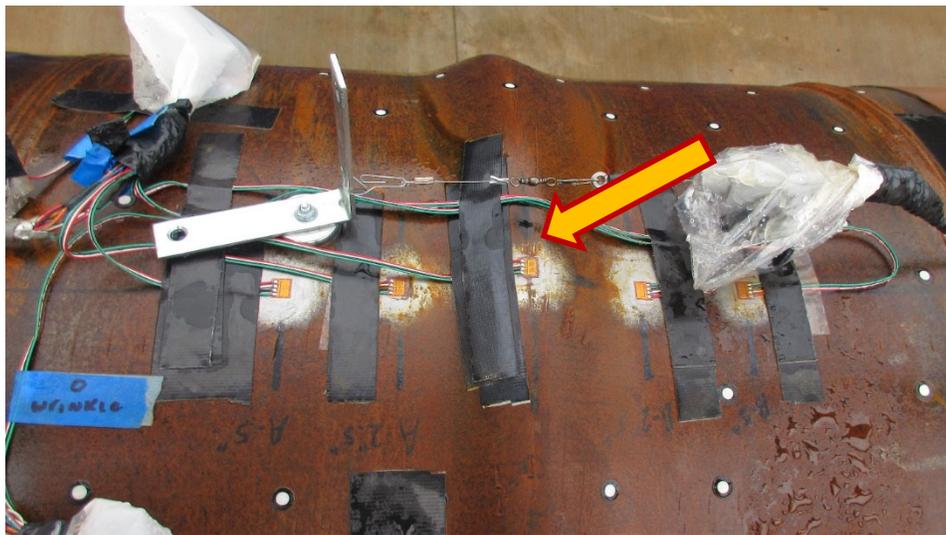
**Figure 14. Photograph showing leak that developed in peak of the wrinkle bend**

Testing was concluded after failure of the wrinkle, which is characterized by a drop in internal pressure due to leaking associated with a circumferential crack that developed in the peak of the wrinkle. The unreinforced sample leaked after 107 bend cycles while the E-glass reinforced sample leaked after 1,774 (an increase of 16.6 times) and the carbon reinforced sample leaked after 863 cycles (an increase of 8.1 times). Provided in Figure 14 is a photograph showing the crack that developed in the peak of the wrinkle of the unreinforced test sample.
