Study to Validate the Design of Carbon-Epoxy Technology used in the Reinforcement of Crack-Like Features

Travis Greenstreet¹, Chris Alexander¹, Jim Souza², Osbaldo Chavez²,
Sammy Goodgion², and Steven Siever²

Pipeline Pigging and Integrity Management Conference

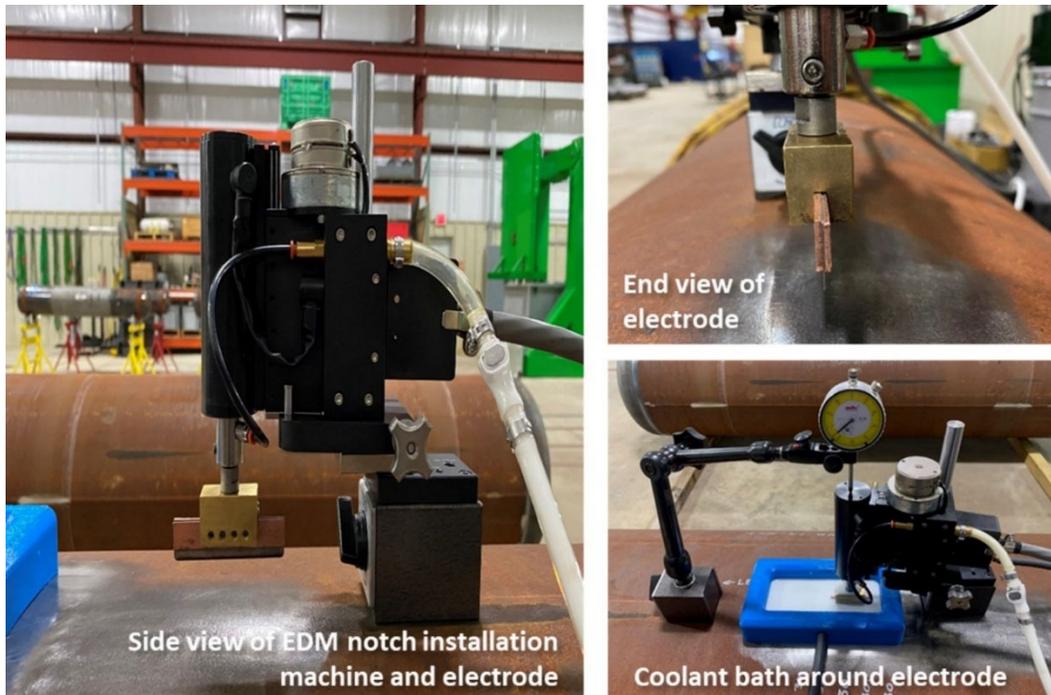
Figure 1. EDM notch installation setup (3)

The process consists of taking a graphite electrode that has been formed into a know length and width and plunging it into the bondline. In this specific application, the electrode was 0.015-in in thickness and 3-in in length. An example of the setup used for plunging the electrode into the pipe can be seen in **Figure 1** and an example of an installed EDM notch can be seen in **Figure 2**. Notches were made to be 30% the measured wall thickness of the test samples.

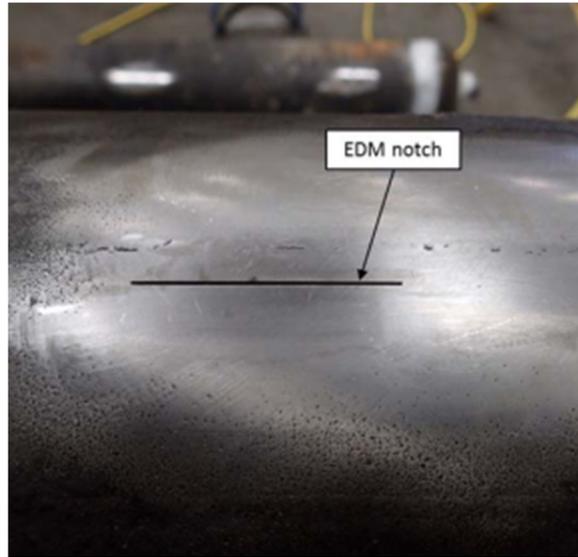
Figure 2: EDM notch installed in external pipe wall (1)

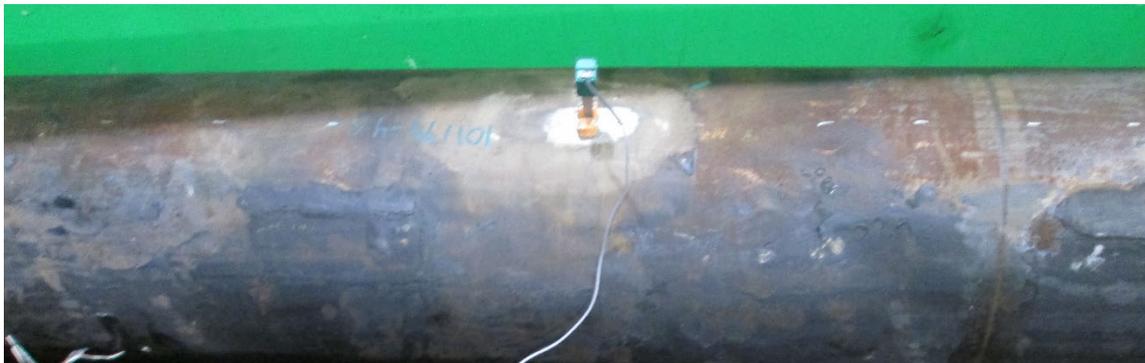
Figure 3: Unreinforced sample during precycling with clip-on displacement gage installed

All six reinforced samples were subjected to continuous pressure cycling at a range of 100 psig to 1,045 psig, which corresponds to 7% to 72% SMYS. 72% SMYS was selected as the top end pressure due to it being the maximum allowable operating pressure for pipelines in the United States. The notches were monitored for growth through the use of clip-on displacement gages that were installed over the center of the feature. **Figure 3** shows an example of a sample during pre-cycling with the clip gage installed. Crack growth can be inferred from this reading when an exponential increase in the flexing of the notch opening initiates as this indicated the depth of the feature is increasing. **Figure 4** shows the reading of the clip-on displacement gage versus number of pressure cycles for one of the samples during pre-cycling.

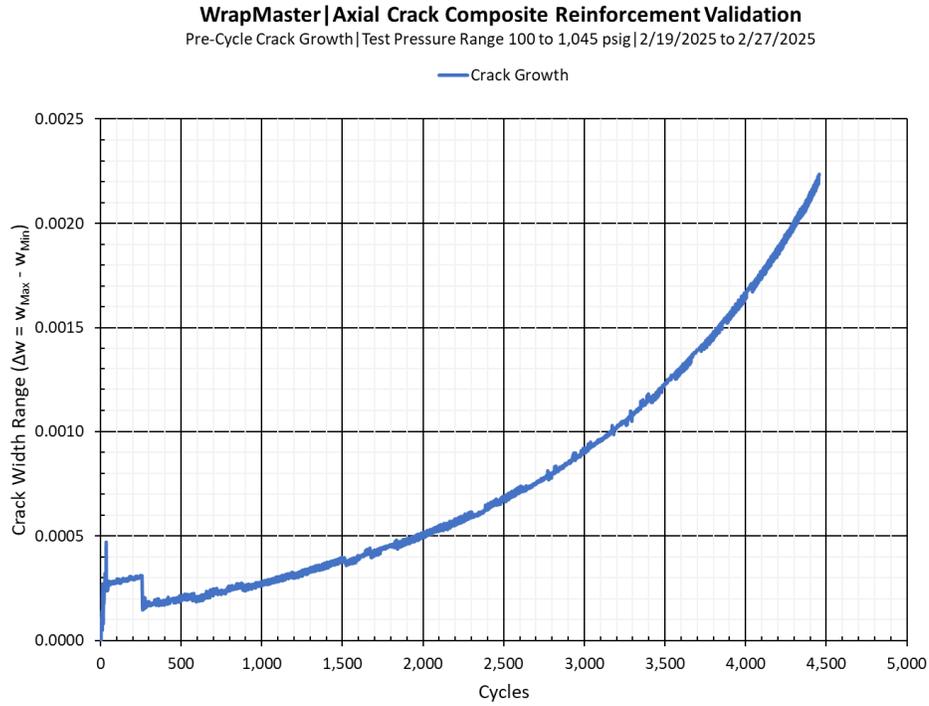
Figure 4: Clip -on displacement gage reading vs number of pressure cycle during pre-cycling

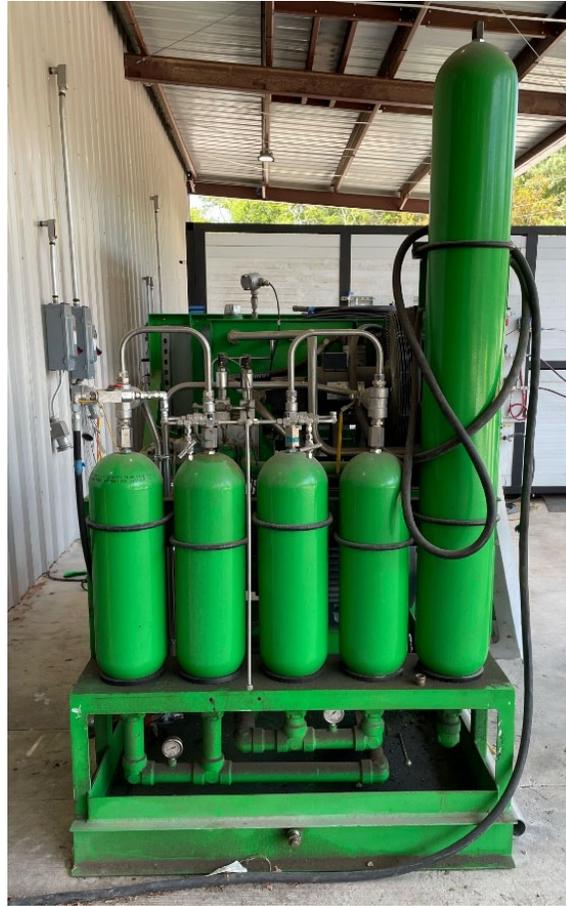
Figure 6. Pressure cycle pumping unit

Two forms of pressure loading were used to test the performance of the reinforced samples, short-term burst and pressure cycling. A single unreinforced sample was used in both of these load cases to provide a baseline for comparing reinforced results to. A single reinforced sample was subjected to short-term burst testing with no additional pressure cycling. The remaining three reinforced samples were all subjected to a runout of 25,000 pressure cycles at a pressure range of 100 psig to 1,045 psig, which corresponds to 7% to 72% SMYS. 72% SMYS was selected as the top end pressure due to it being the maximum allowable operating pressure for pipelines in the United States. An example of one of Acuren's pressure cycle units can be seen in Figure 6.

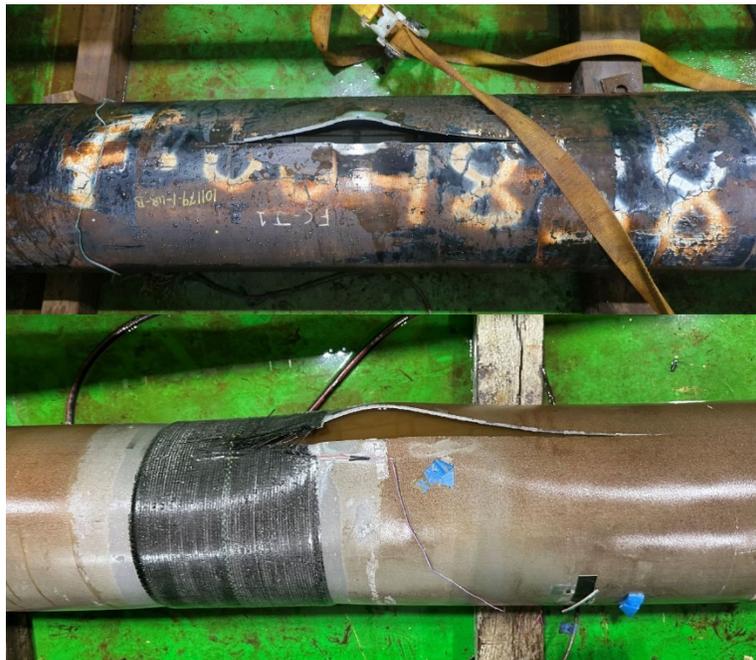
Figure 7: Sample 1-UR-B (top) and 5-R-C (bottom) post short-term burst test

Of the four burst samples, only the unreinforced sample (1-UR-B) experienced failure in the crack like feature. All three reinforced samples experience failure in the unreinforced steel outside of the repair. A photo of the unreinforced failure and the reinforced failure of samples 5-R-C can be found in Figure 7.

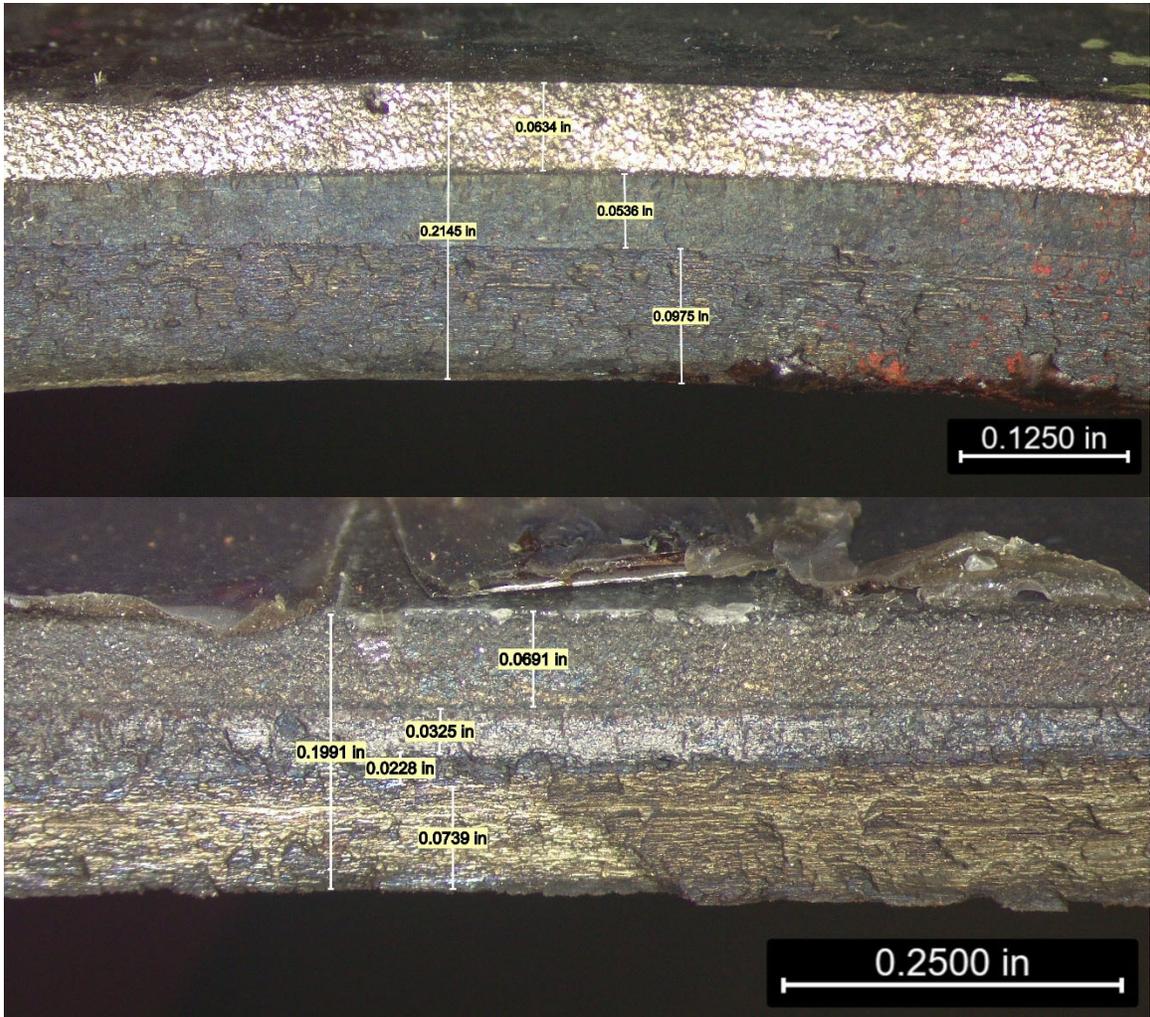
Figure 8: Sample 1-UR-B (Top) and 5-R-C (bottom) macrographs

After samples had been tested to failure, the features were broken open for a post-test metallurgical analysis to help determine the amount of crack growth that had occurred throughout testing. EDM notch depth and crack growth can be determined by observing side profiles of the feature. Cracks were heated past 400 °F after they completed pre-cycling to form a bluish hue on the exposed portions of the feature. This process allows for the regions of crack growth that were before and after the installation of the repairs to be distinguishable. Metallurgical macrographs of an unreinforced (1-UR-B) and reinforced (5-R-C) sample can be found in Figure 8.
