## COMPOSITE REPAIR OF LARGE-SIZE DIAMETER PIPE WITH SEVERE METAL LOSS DEFECTS

### ABSTRACT

## 2. ELEVATED TEMPERATURE COMPOSITE REPAIR DESIGN AND TESTING

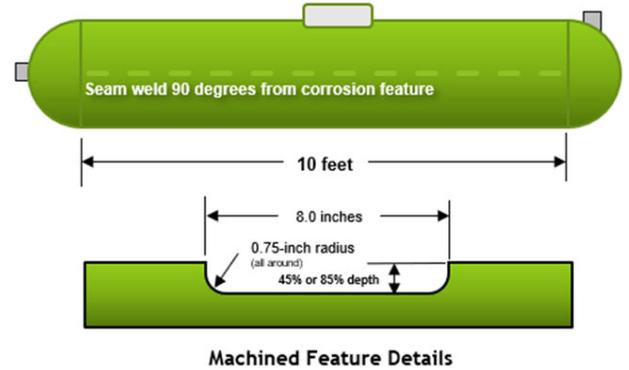
The two types of non-leaking corrosion features included the following geometries with depths of 45% and 85% of pipe NWT (see FIGURE 1 to FIGURE 4):

- General corrosion with geometry of 8-inch (l) x 6-inch (w) (203.2 mm x 152.4 mm).
- Groove corrosion with geometry of 8-inch (l) x 1-inch (w) (203.2 mm x 25.4 mm).

FIGURE 1: Schematic Showing Machined Corrosion Location

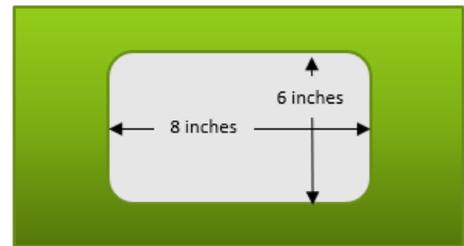
FIGURE 3: General Corrosion Feature Geometry

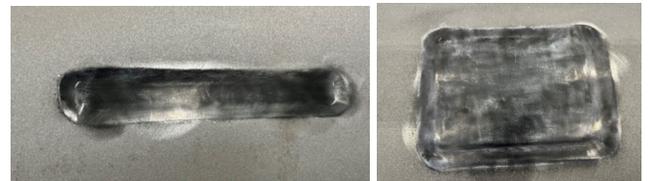
FIGURE 4: Photographic Examples of Machined Corrosion Features Geometry

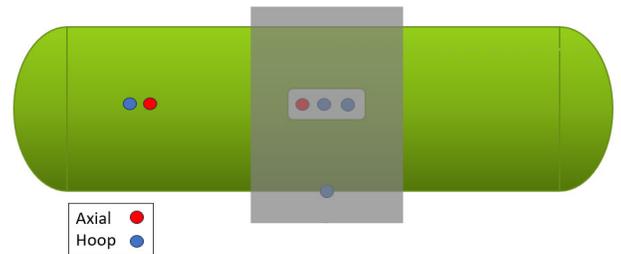
Also included in Table 1 is the estimated number of cycles to failure based on the reduced stress state in the corroded region of the pipe due to the specified reinforcement. In order to assess the temperature impact, all installations were completed with no internal pressure and at ambient room temperature. Strain gauges were installed in the corrosion features before the installation of repairs to permit measurement of strain beneath the repairs in the reinforced corrosion regions (see FIGURE 5). FIGURE 6 is a photograph of the test setup that includes insulation placed around the sample to maintain the 60°C (140°F) temperature during testing.

**FIGURE 5:** Sample Strain Gauge Locations

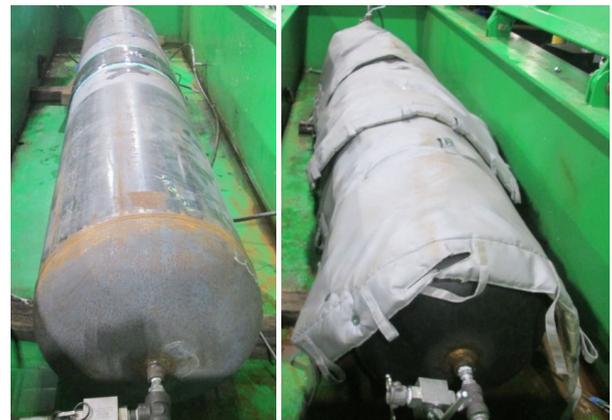
(Left sample without insulation, right sample with insulation)

**FIGURE 6:** Sample Strain Gauge Locations

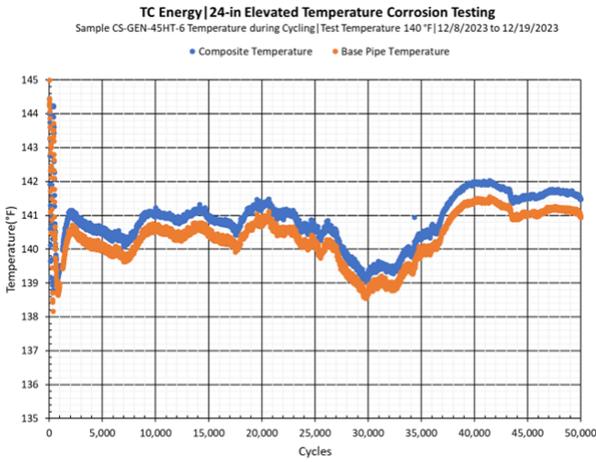
The composite and steel base pipe temperatures were continuously measured during each sample's cycling runout. FIGURE 7 shows temperatures of CS-GEN-45HT-6 as an example of how temperatures behaved during runout, verified to be 140°F plus or minus 2°F (+/- 1.4%).

**FIGURE 7:** CS-GRV-45HT-6 Temperatures During Cycling

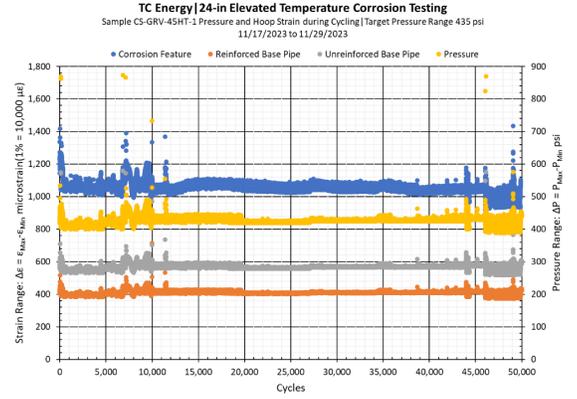
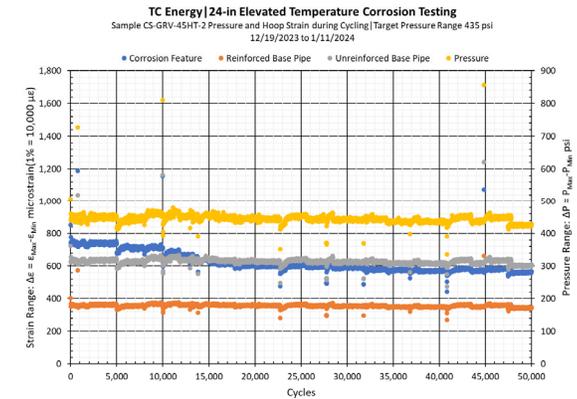
As expected, all samples with features of 45% wall loss were able to achieve the 50,000 cycle runout. For strain and pressure readings from the 45% wall loss samples, see FIGURE 8.

**FIGURE 8:** CS-GRV-45HT-1 and CS-GRV-45HT-2 Pressure and Hoop Strain During Cycling

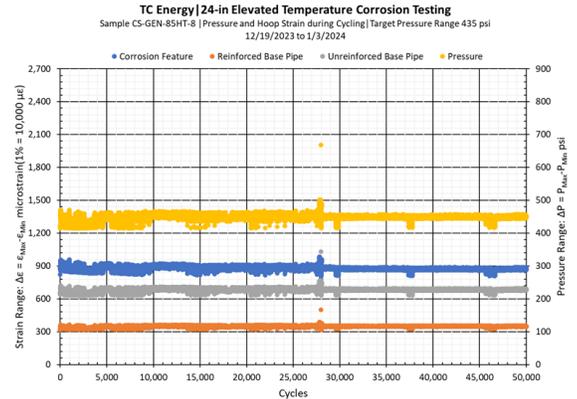
Only one of the 85% wall loss samples completed the target runout of 50,000 cycles. Its strain and pressure readings are provided in FIGURE 9.

**FIGURE 9:** CS-GEN-85HT-8 pressure and hoop strain during cycling

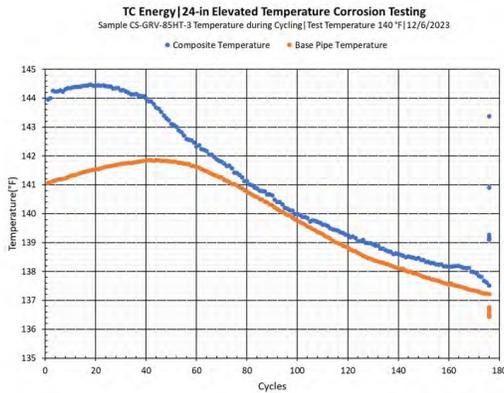
Sample CS-GRV-85HT-3 is believed to have begun leaking at 25 cycles, despite its cycles to failure being listed at 176 cycles in Table 2. The repair held pressure enough to allow for cycling to continue; however, the data suggest a leak formed earlier in the cycle process. FIGURE 10 shows the temperature of CS-GRV-85HT-3 during its entire runout. The significant temperature drop that begins at 25 cycles indicates that hot water was leaving the system, and ambient tap water

used to supply cycle pumps was added at a rate that exceeded the heating capacity of the heater.

**FIGURE 10:** CS-GRV-85HT-3 Temperature During Cycling

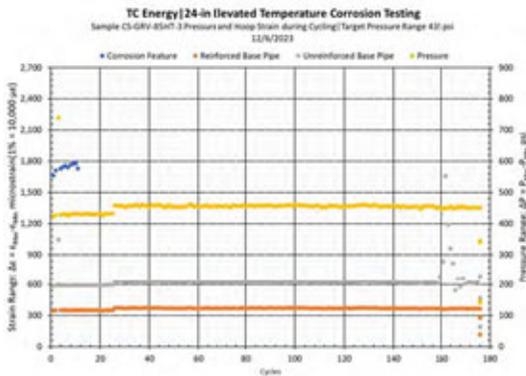
Furthermore, the pressure data in FIGURE 11 shows a sudden jump in the pressure range at 25 cycles. Because a pressurized reservoir maintains the bottom-end pressure for cycling, the system loses an excessive amount of fluid that causes the bottom-end pressure to drop and increases the pressure range.

**FIGURE 11:** CS-GRV-85HT-3 Temperature During Cycling

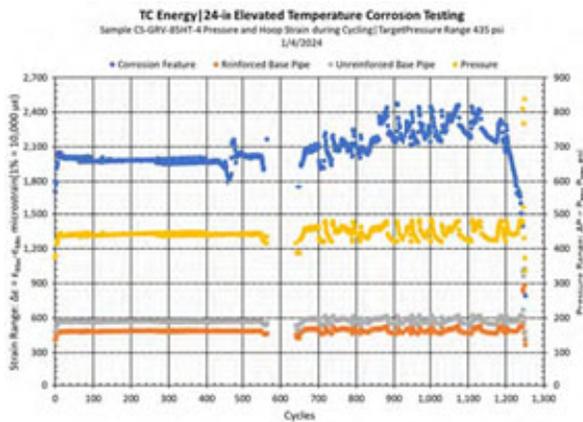
**FIGURE 12:** CS-GRV-85HT-4 Pressure and Hoop Strain During Cycling

For pressure and strain data from sample CS GRV-85HT-4, see FIGURE 12; for CS-GEN-85HT-7, see FIGURE 13.

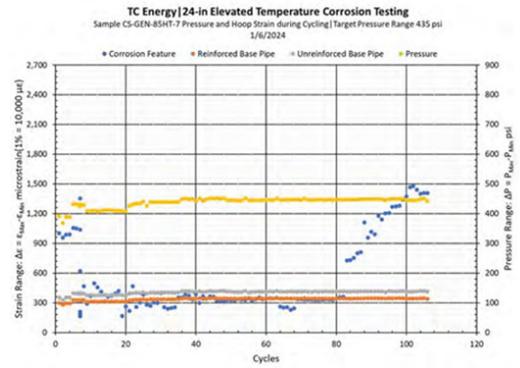
**FIGURE 13:** CS-GRV-85HT-7 Pressure and Hoop Strain During Cycling

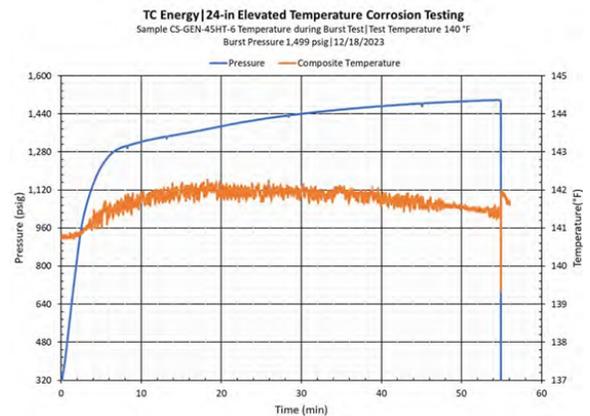
FIGURE 14 shows the internal pressure and composite temperature of CS-GEN-45HT-6 during testing, and FIGURE 15 shows strain under the repair and in the base pipe during testing. Note that the unreinforced base pipe gauge showed excessive yielding and disbonding before reaching burst, whereas the corrosion feature showed only elastic deformation for the entire test duration.

**FIGURE 14:** CS-GEN-45HT-6 Internal Pressure and Composite Temperature During Burst Test

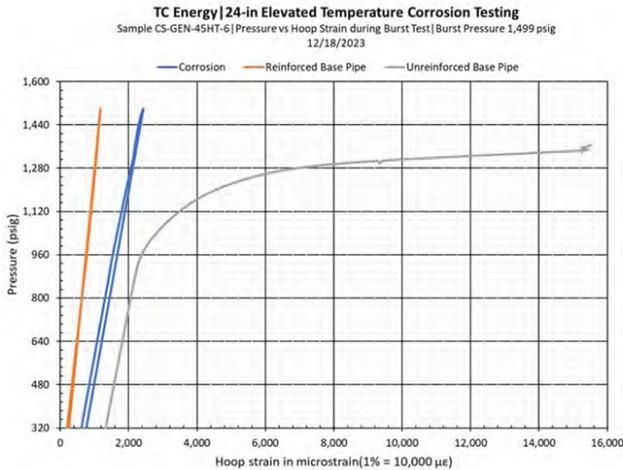
**FIGURE 15:** CS-GEN-45HT-6 Internal Pressure vs. Strain During Burst Test

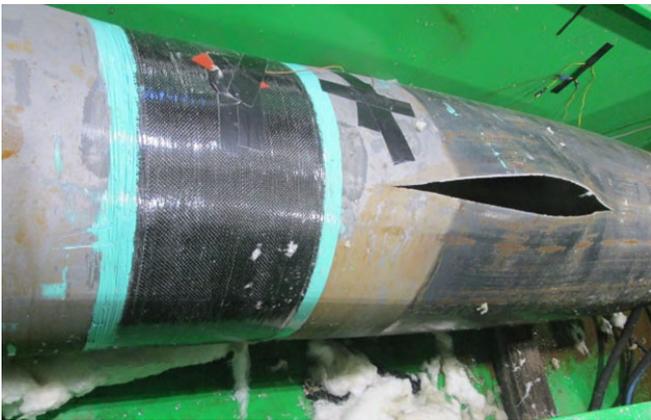
For an example of one sample after burst testing, see the photograph in FIGURE 16.

**FIGURE 16:** CS-GEN-45HT-5 Post Burst Testing
