## **USING TESTING METHODS TO EVALUATE PIPELINE MECHANICAL INTEGRITY**

**Chris Alexander**  
Stress Engineering Services, Inc.  
Houston, Texas  
[chris.alexander@stress.com](mailto:chris.alexander@stress.com)

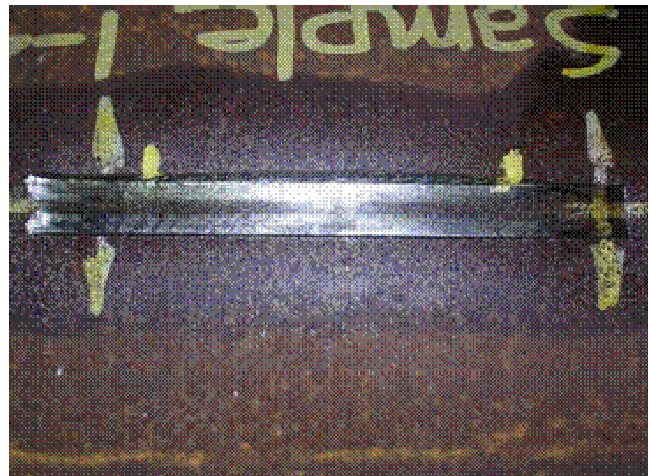
**Figure 4 – Geometry of indenter teeth and resulting damage**  
(drawings at left show indenter geometry and photo at right shows the resulting damage inflicted to the pipe)

**Figure 3** shows the set-up for testing done to generate mechanical damage in 12.75-inch (324 mm) diameter pipe material. To inflict damage a gouge was generated by forcing a back-hoe tooth into the sample that was simultaneously pulled, during which pressure was maintained in the sample at 70% SMYS. **Figure 4** shows the geometry for the three back-hoe teeth as well as a photograph of one of the simulated defects.

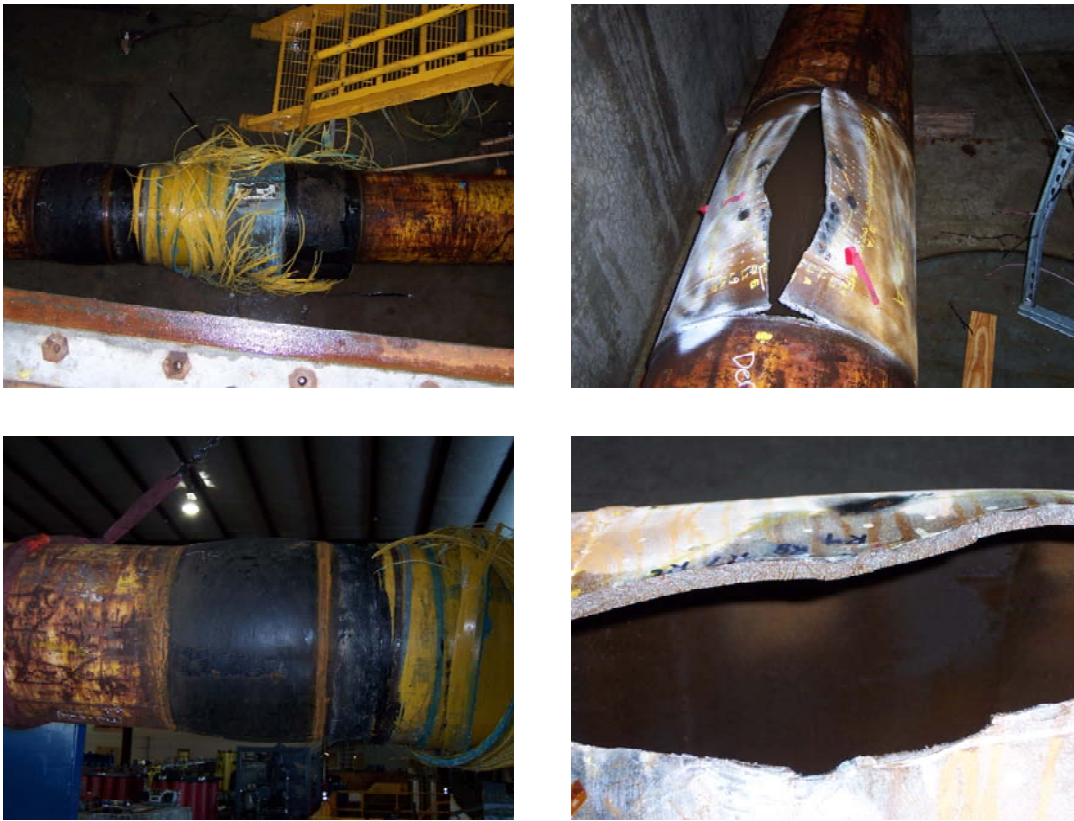
**Figure 8 – Photographs from two burst tests that included repaired and unrepaired dents**  
(the two left photos show a dent repaired using the Clock Spring composite repair system)

Each of the three samples was burst tested. Of the two dents without the composite repair, strain was monitored during testing. **Figure 7** shows strain gage readings taken during one of the burst tests. This particular sample failed at 2,291 psi (15.8 MPa) and the maximum strain recorded during testing was at Gage #8, a gage located remote from the dent (a result that confirmed to the operator that there concerns regarding the dent were not warranted). Several photographs from this program are provided in **Figure 8**.

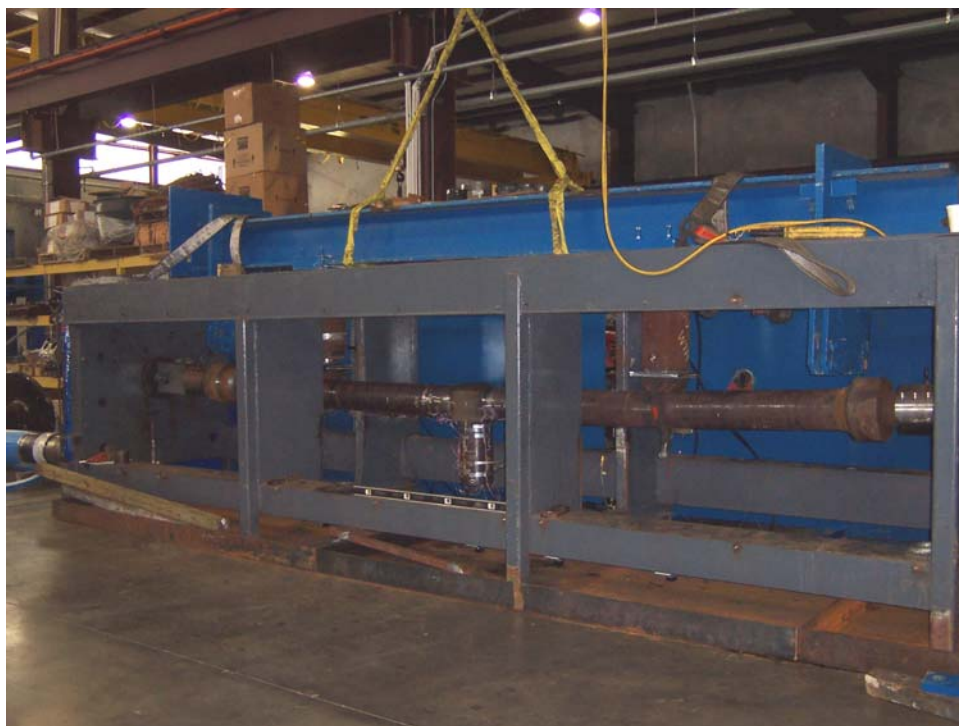
Figure 10 – Load frame used for pressure-tension-bend testing

**Figure 9** and **Figure 10** provide a schematic of the test samples with strain gage locations and a photograph of the load frame, respectively. The simulated corrosion shown in **Figure 9** is certainly an extreme case in that the geometry axisymmetric (i.e. the same all the way around the pipe). This was done for two reasons. First, damage to offshore risers often occurs randomly around the riser and is especially prevalent at the air-water interface in the splash zone. Secondly, it is necessary that the tested composite repair systems demonstrate their ability to provide reinforcement all the way around the riser.

The load frame shown in **Figure 10** has a tension capacity of 1 millions lbs and a bending capacity of 750,000 ft-lbs (1017 kN-m). The primary objective in testing was to demonstrate the capability that

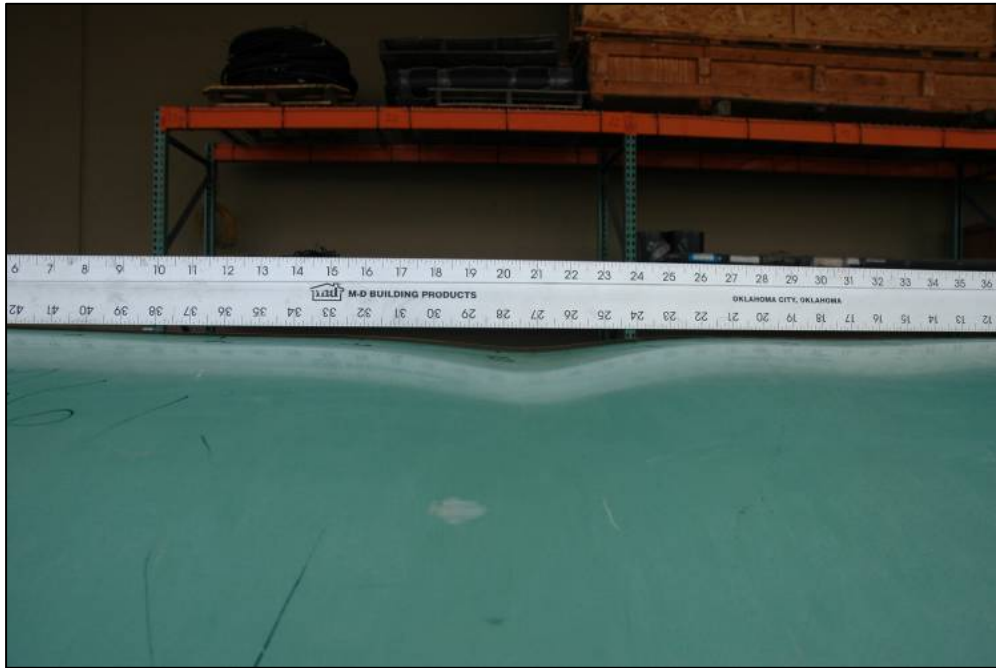
Figure 12 – Photograph of flat spot in pipe prior to cyclic pressure fatigue testing

The author was contacted by a gas pipeline company who had detected flat spots in a new large diameter pipeline during the commission phase efforts. The operator had questions about the acceptability of these flat spots and what long-term threat they posed to the integrity of the pipeline. **Figure 12** is a photograph showing the side view of one of the flat spots.

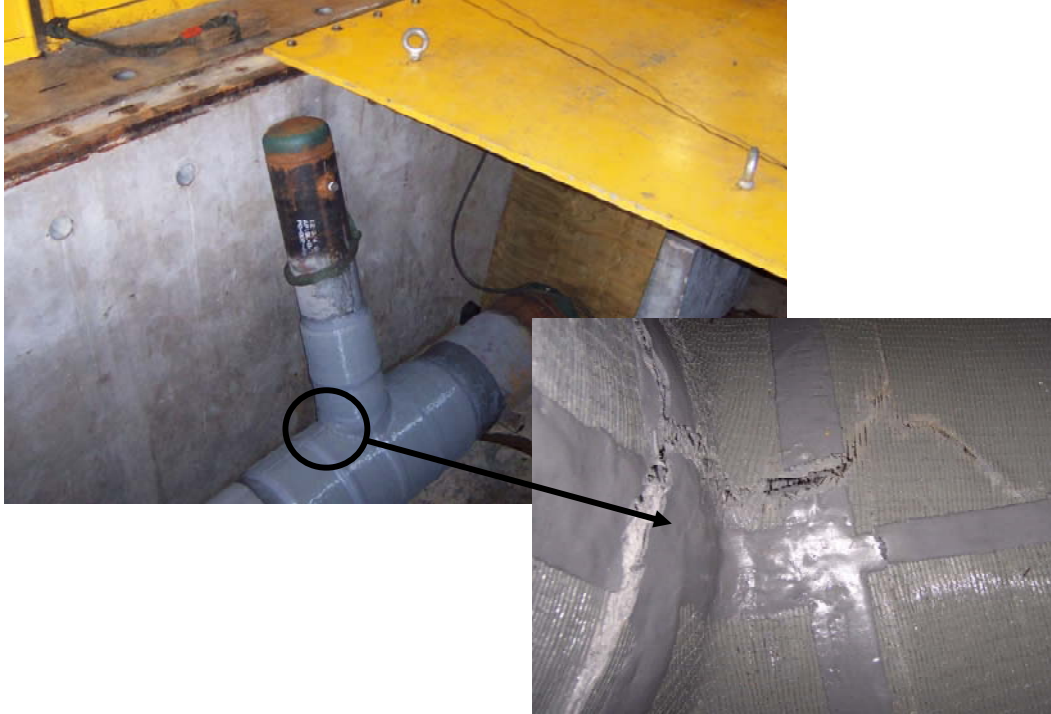
Figure 16 – Leak that developed in composite-reinforced branch connection

Once all analytical efforts were completed, a full-scale test was performed on an exemplar branch connection fabricated from a 24-in x 0.375-in pipe (610 mm x 9 mm) and a branch pipe fabricated from 12.75-in x 0.375-in pipe (323 mm x 9 mm) where both pipe are Grade X42. Pressure levels exceeding 2.9 times the MAOP of the 24-inch pipe (787 psi, 5.4 MPa) were reached before the branch connection leaked at a maximum pressure level of 2,314 psi (15.9 MPa). This burst pressure is 1.76 times SMYS. A burst in the connection did not occur, but rather a leak developed in the weld joining the branch and the run pipes and most likely initiated in the crotch region where the highest levels of strain occurred during pressure testing. **Figure 16** shows the test set-up with a close-up view of the region where the crack and leak occurred.
